RECALL BULLETIN

DATE: OCTOBER 2, 1995
MODEL YEAR: 1995
MODELS AFFECTED: UD1800/UD2300/UD2600/UD3000
BULLETIN #: SC-176
FILE AT END OF ELECTRICAL SECTION IN TECHNICAL BULLETIN BINDER

VOLUNTARY SAFETY RECALL CAMPAIGN #95V-176
(FORMERLY INTRODUCED AS PI-026 DATED APRIL 19, 1995)

WIRING HARNESS PROTECTOR

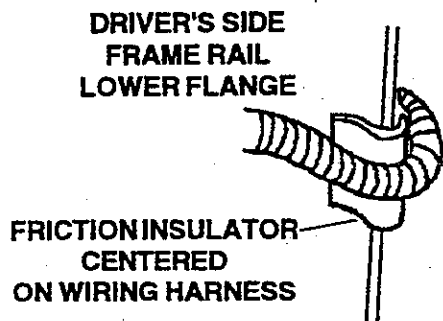
The possibility exists that the vehicles may experience wiring harness protector chafing or rubbing on the driver's side lower frame rail flange, causing possible breakage of the wiring harness protector and exposure or breakage of the wiring. Breakage of the wiring could cause loss of electrical power to various components or systems, including the headlights and windshield wipers.

Install the plastic friction insulator on the frame rail lower flange with a permanent adhesive such as Super Glue, 3-Bond, Quicktite, or a suitable equivalent. The insulator should be centered on the wiring harness as shown in the figure below.

If the wiring harness protector is torn or separated, apply electrical tape to the affected area to seal the harness protector, then install the friction insulator. If any of the wires are exposed or broken, repair the affected wires, apply electrical tape to the affected area of the harness protector, then install the friction insulator.
