NISSAN DIESEL AMERICA, INC. RECALL BULLETIN

DATE: AUGUST 30, 1999
MODEL YEAR: 1998 ~ 2000
MODELS AFFECTED: UD1200/UD1400
BULLETIN #: SC - 209

VOLUNTARY SAFETY RECALL CAMPAIGN #99V - 209:
1998 ~ 2000 MODEL YEAR UD1200 AND UD1400 FRONT STEER AXLE TIRE REPLACEMENT

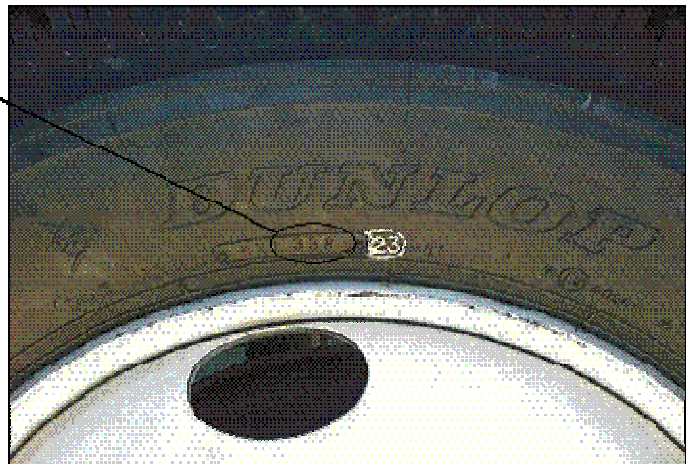
D.O.T. SERIAL NUMBER EXAMPLE

Dunlop Tire Corp. has determined that affected SP LT5 tires manufactured within a certain D.O.T. serial number range were installed on some of the listed vehicles. A D.O.T. serial number is a 10-digit code stamped into one side of the lower sidewall. The last three digits indicate the week and the year that the tire was produced, as illustrated below.

AFFECTED TIRE D.O.T. SERIAL NUMBER RANGES:

UD1200

U2BA7KL308 ~ 129

UD1400

U2BAWKL198 ~ 129

Inspect the front steer axle tire D.O.T. serial numbers of listed vehicles. If one or both front steer axle tire D.O.T. serial numbers on a listed vehicle fall within the ranges shown above, proceed with tire replacement according to the following instructions. If not, place a mark in Box 01 (Inspected - No corrections necessary) of the "AUTHORIZATION FOR RECALL SERVICE" card and return it to NDA.
