# TECHNICAL BULLETIN FC-01

DATE: NOVEMBER 7, 2005 (Revised 1/07)  
 MODEL YEAR: 2005 AND AFTER  
 ENGINE MODEL: J05D-TA and J08E-TE  
 CHASSIS MODEL: UD1800CS, UD1800HD ~ UD3300  
 BULLETIN NUMBER: FC-01  
 FILE IN THE FUEL SECTION OF THE TECHNICAL BULLETIN BINDER

## ENGINE THROTTLE CONTROL SWITCH MOUNTING

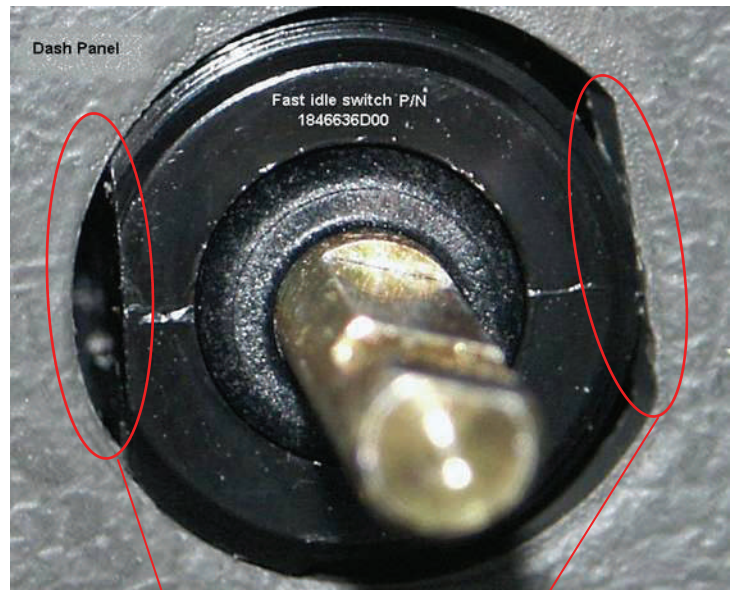
### Wiring Schematic

If the engine throttle control switch has rotated in the mounting hole, damage to the switch wiring harness can occur. This can cause multiple engine diagnostic fault codes simultaneously displayed such as:

DTC	Description:
P0405	EGR lift sensor 1
P0407	EGR lift sensor 2
P0340	Engine speed sub sensor

Proceed to inspect for a twisted Engine Throttle Control Switch wiring harness and repair as required in addition to performing the normal diagnostic procedures for the indicated trouble codes.
