# TECHNICAL BULLETIN TR-19

DATE: JANUARY 16, 2004  
 MODEL YEAR: 1999 AND AFTER  
 TRANSMISSION MODEL: AISIN AUTOMATIC TRANSMISSION  
 BULLETIN NUMBER: TR-19  
 FILE IN THE TRANSMISSION SECTION OF THE TECHNICAL BULLETIN BINDER

## AISIN AUTOMATIC TRANSMISSION OUTPUT FLANGE NUT SERVICE PROCEDURES

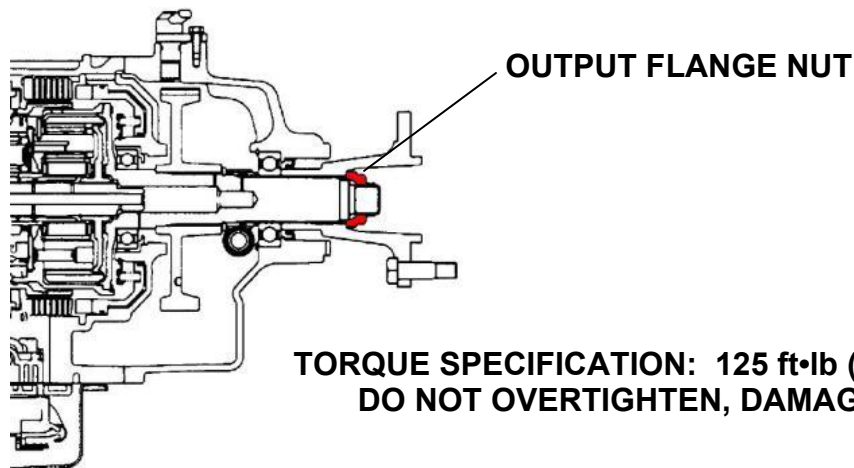
### STAKE NUT WITH CHISEL

The following information emphasizes the importance of proper installation and torque setting for the Aisin Automatic Transmission output flange nut. Failure to follow the prescribed procedures will result in damage to the transmission.

Whenever repair or service procedures require the removal of the output flange nut on the Aisin Automatic Transmission, it is required that a new flange nut part number 33143-29D00 and O-ring part number 31526-29D05 be installed.

- Install flange yoke with the end caps 90° to the slotted grooves on the output shaft.
- Lubricate the output shaft O-ring with clean ATF and install over the output shaft in the recess of the output flange yoke.
- Install the output flange nut by hand and then torque to the specified value utilizing a torque wrench only.

**WARNING:** Do not exceed the specified torque of 125 ft•lb (170 N•m, 17.3 kgf•m).

- Properly stake the output flange nut onto the output shaft as shown on the right using a blunt chisel.
